## National Transportation Safety Board Aviation Accident Preliminary Report

<b>Location:</b>	Burns, OR	<b>Accident Number:</b>	WPR19LA020
<b>Date &amp; Time:</b>	10/27/2018, 0750 PDT	<b>Registration:</b>	N3267S
<b>Aircraft:</b>	Cessna 182	<b>Injuries:</b>	3 None
<b>Flight Conducted Under:</b>	Part 91: General Aviation - Personal

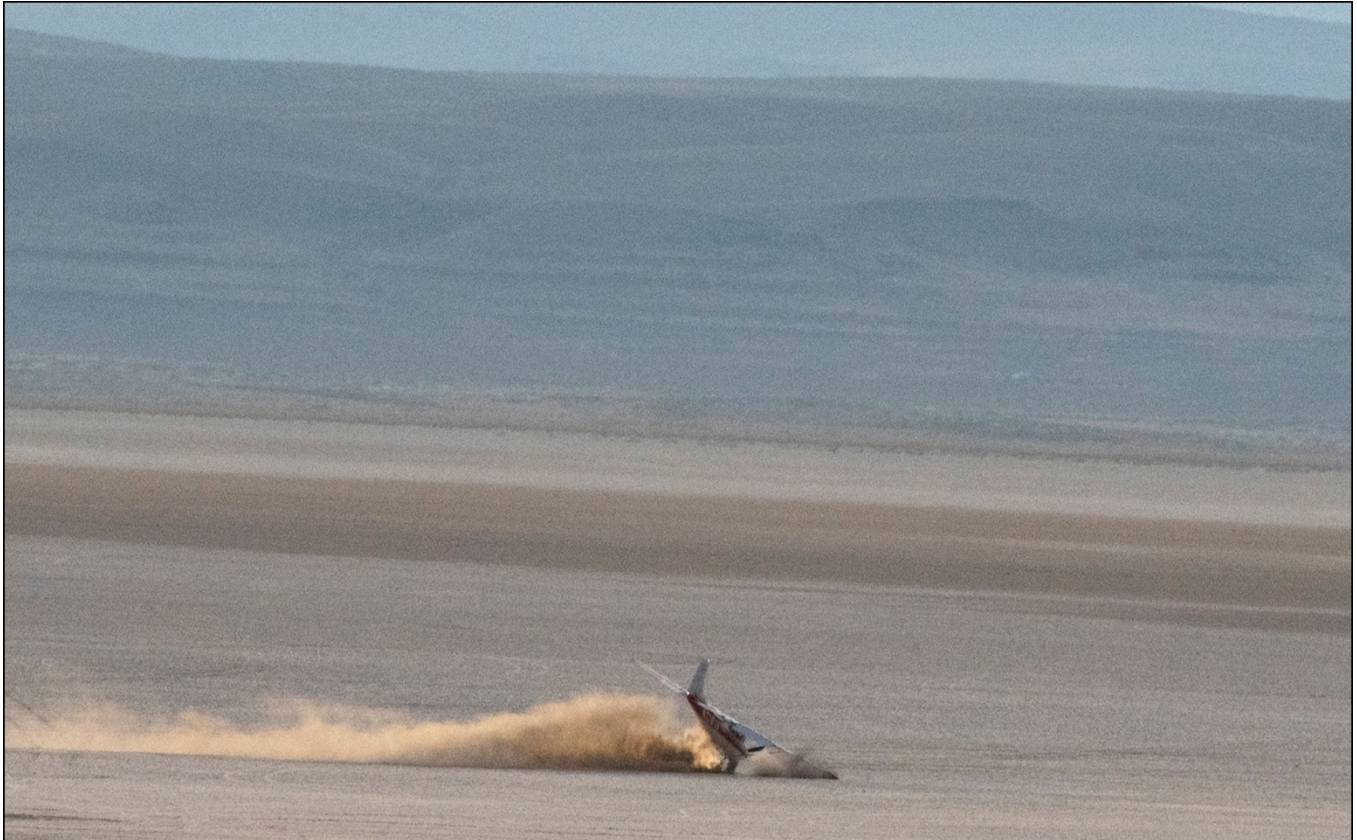
A witness reported that she observed airplanes landing on the flats and decided to take photographs that captured part of the accident sequence. (refer to picture 01). She stated that the accident airplane touched down and the airplane suddenly pitched up in the air with the nose being pushed into the desert terrain.

Picture 01: Witness's Photograph of the Accident

A Federal Aviation Administration inspector that examined the wreckage stated that the left main landing gear attach bolts had an appearance consistent with having sheered as a result of materials failure. The landing gear was retained for further examination.
